BUILDING SURVEY REPORT

PROPERTY Sample Survey
11 Florence Street
Anytown
AA11 1AA

SURVEY DATE 20 Nov 2019

REF 3974

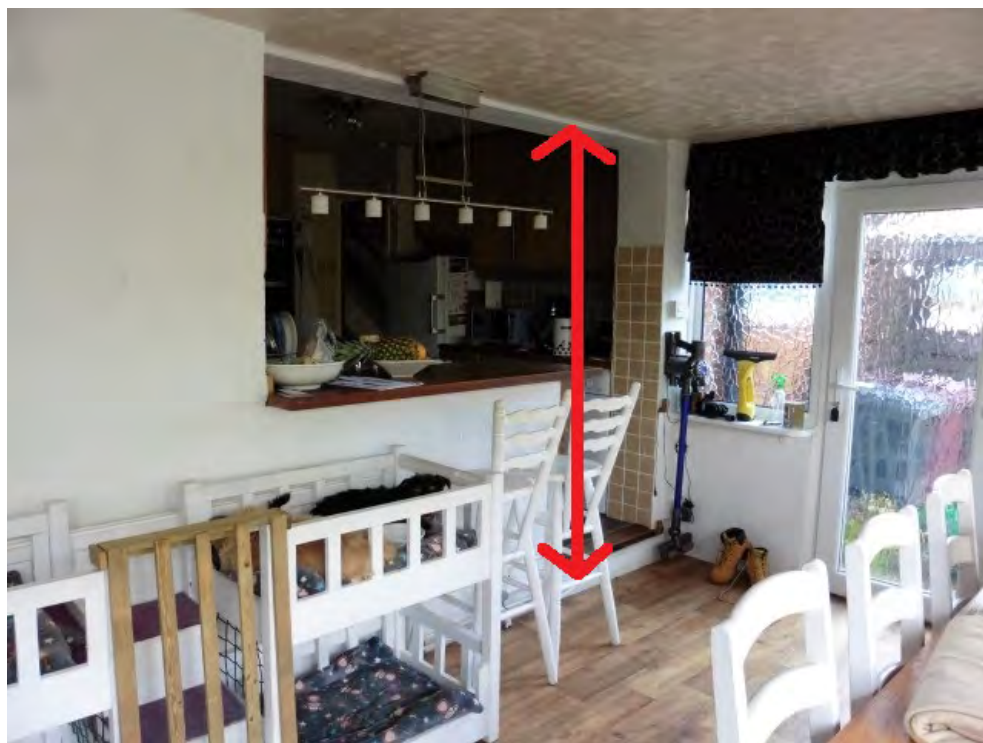
Wall partially removed between the kitchen and sun room

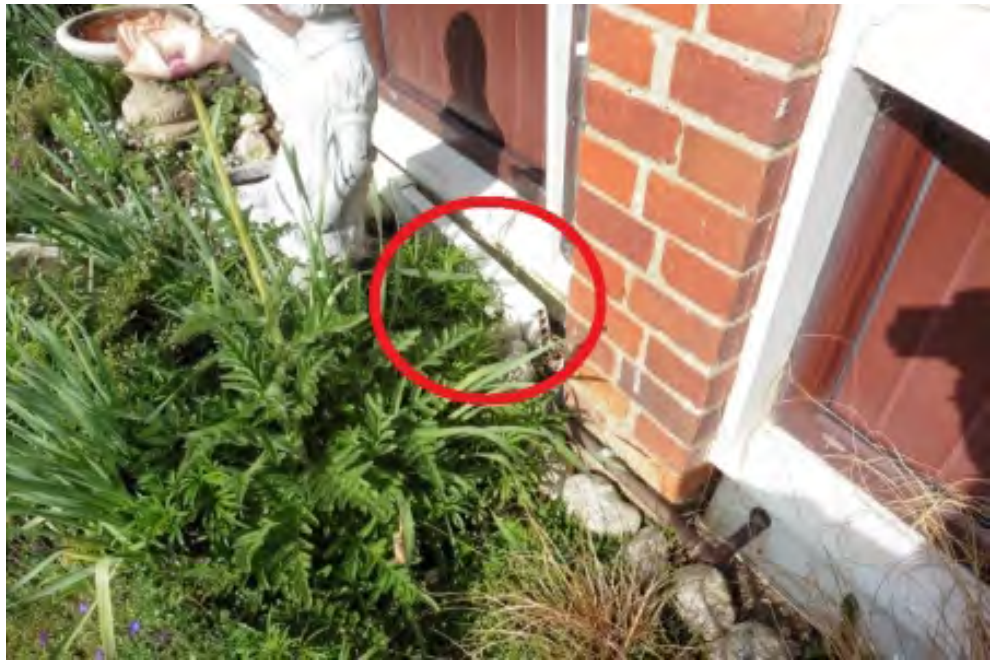
Loose plastic trim at the front

Action Required	<p>Walls should be examined regularly to inspect for changes in the nature of any cracking or other defects that may become apparent.</p> <p>You should carry out a thorough visual inspection at least once a year, ideally in the Spring to identify and repair any damage that could have been caused by winter weather.</p> <p>The plastic trim at the front should be repositioned.</p>

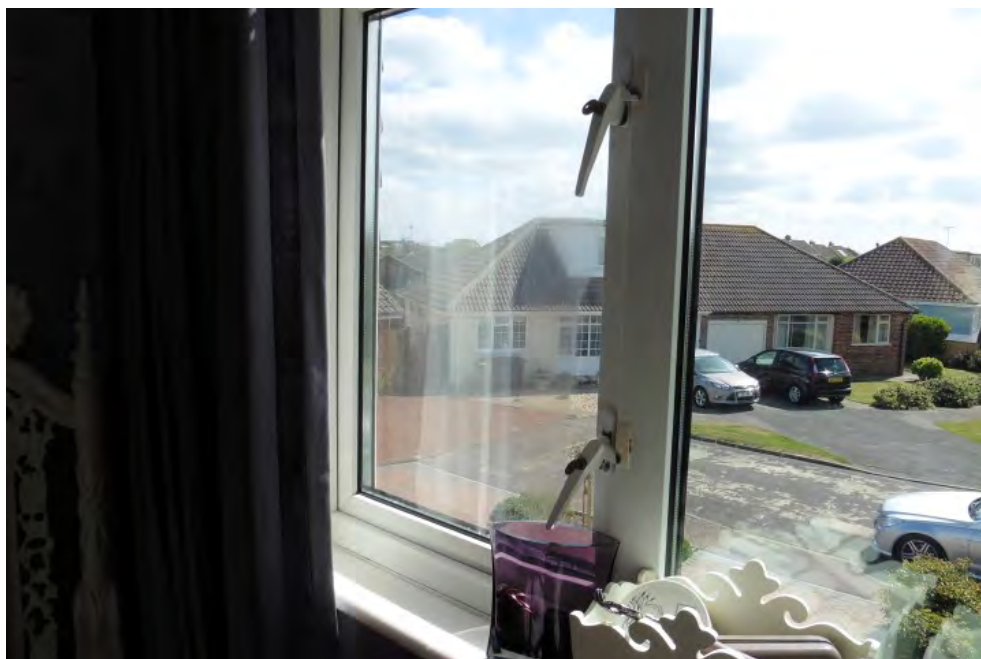
Condition	<p>No significant defects were noted and most of the windows and doors checked were found to operate normally. However, some were found to be quite difficult to operate, probably due to a lack of lubrication of locks and hinges. The handle of the bathroom window on the ground floor is stuck in the open position.</p> <p>A failed sealed window unit was noted in bedroom 1, and other weather conditions may highlight the presence of more. This occurs</p>		
Action Required	<p>Under normal circumstances sealed double glazed units can be expected to last between 15-20 years before the seals begin to</p> <p>Failed sealed double glazing units require replacement. It should also be considered that, where some sealed units within a window have failed, others may also fail in due course.</p> <p>Normal maintenance of frames, hinges and locks is required. This includes repair of the bathroom window and the bedroom 1 seal and frame.</p>

Bedroom 1 casement window panel blown

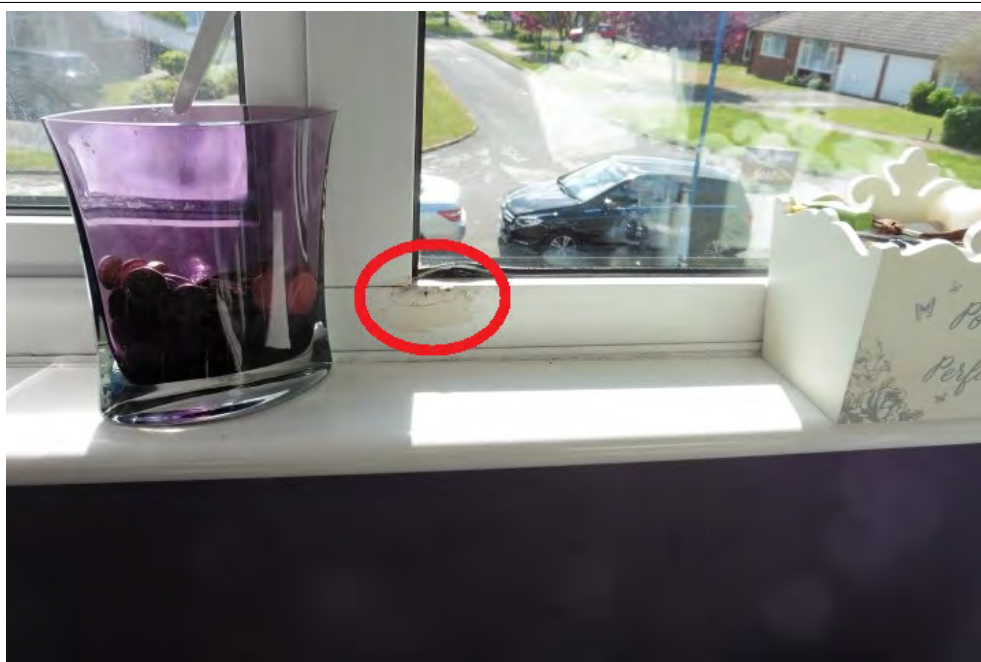
Damage to frame and seal in bedroom 1

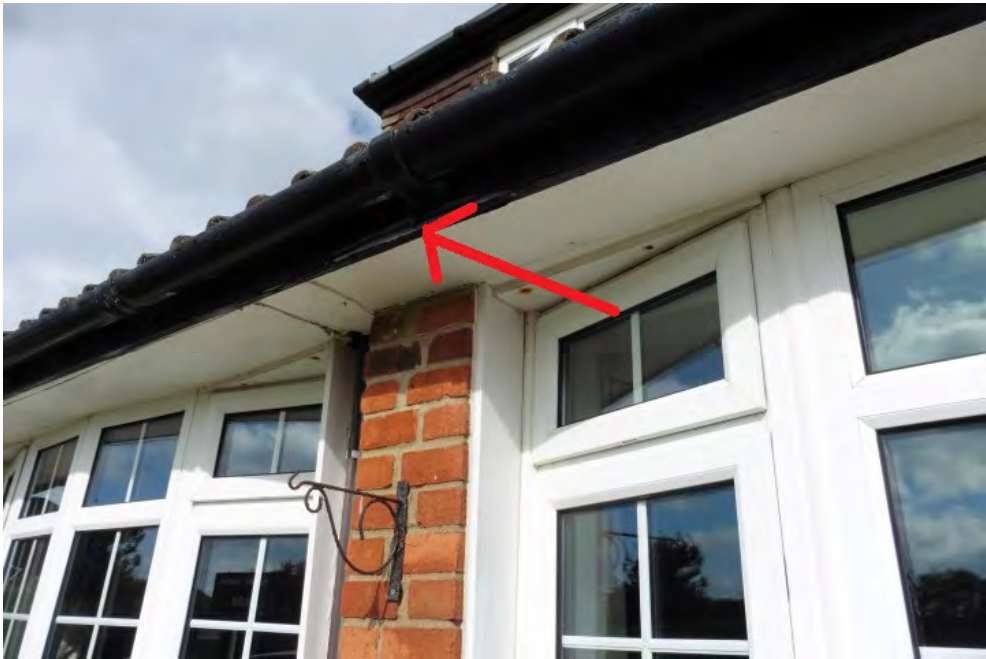
<h3>4.6 External Joinery and Finishes</h3>	Condition rating	3
Construction & Type	<p>This includes such items as woodwork at the roof edges, trim panels and any timber porch/canopy. Soffits are the horizontal timbers joining the fascia boards to the house walls. Fascia boards are the vertical timbers to which the gutters are normally fixed. Barge boards are the diagonal boards at the roof edge on the gable end of the house.</p>		
Nature of inspection and Limitations	<p>All such materials were examined from ground level and with the aid of binoculars from vantage points within the grounds of the property and suitable public areas around. Decorations were examined for indications of poor maintenance, rot and other defects.</p>		
Condition	<p>Widespread evidence was found of rot in the external joinery, including both the fascias at the front and the soffits at the back. The timber is failing and what we have spread to other parts of the building.</p>

<p style="text-align: center;">Rot in the fascia at the front</p>

Action Required	<p>Urgent repairs are required to replace rotten timbers around the edges of the roof. Although some areas of rot were identified, others may be present, and it is possible that the ends of the roof rafters may have been affected. A thorough investigation should be carried out to identify all rotten timber, which should be cut out and replaced. This work is considered to be of an urgent nature and should be carried out immediately upon occupation of the property.</p>

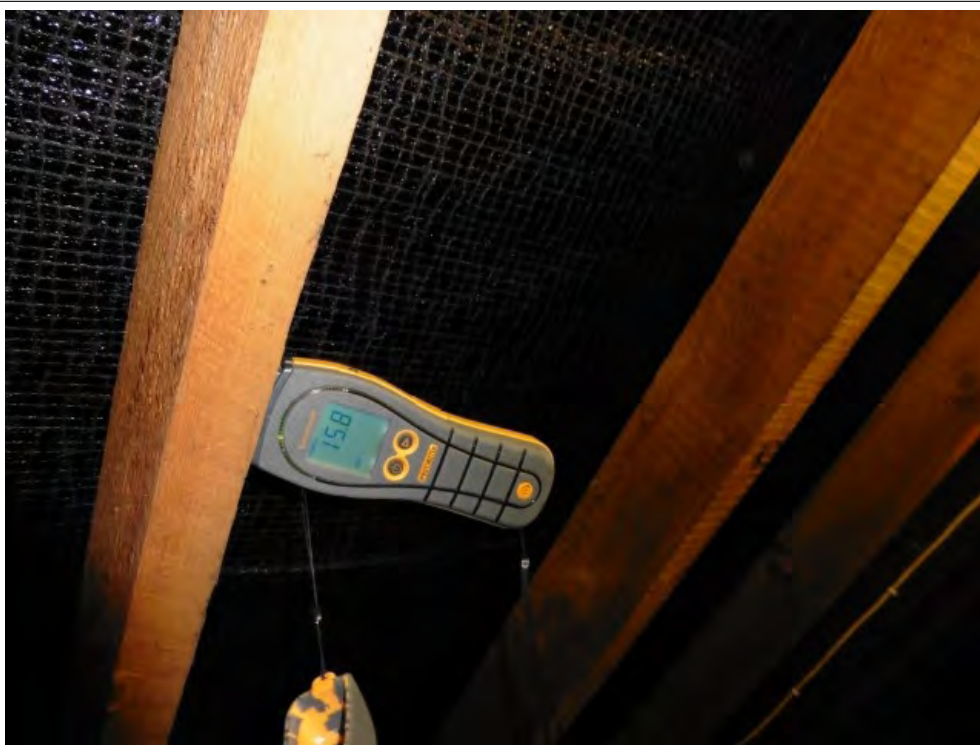
Normal moisture reading in roof timber

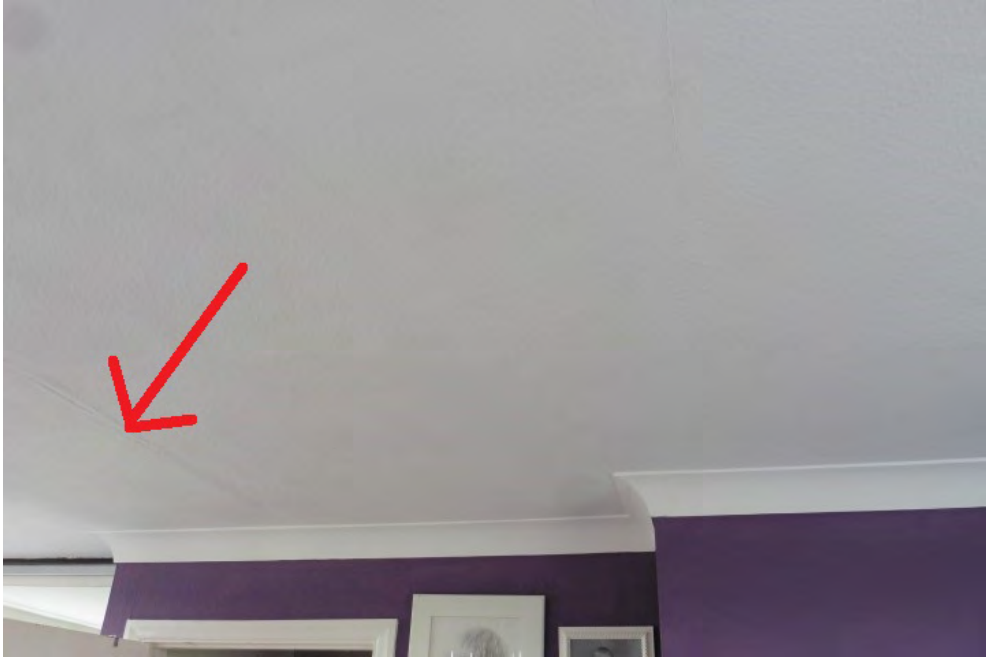
<p data-bbox="692 1585 1129 1615">Straight cracks on the bedroom 1 ceiling</p> </div>

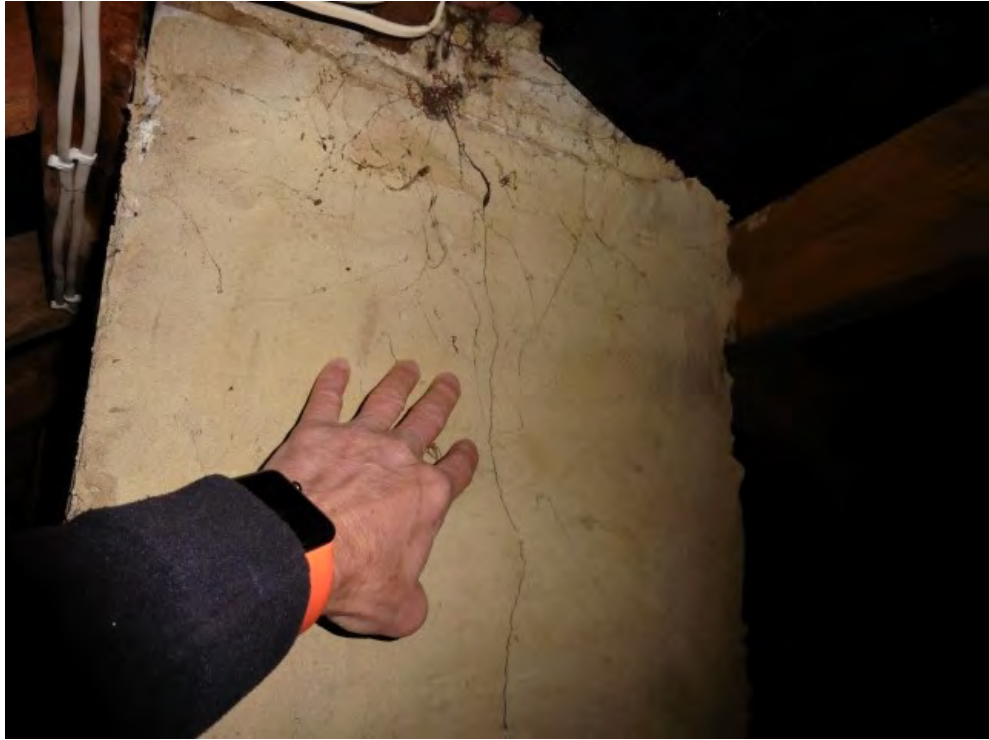
Condition	<p>Although no specific evidence of any structural defects was identified, it is possible that some changes have been made to the right side chimney breast which have the potential to lead to structural failure.</p> <p>Within the kitchen there is no lower part to the chimney breast. Although this type of arrangement is not unusual and was usually accompanied by a flue pipe leading to a boiler or stove beneath, without knowing the history of the building it is impossible to confirm that this is how it was constructed and that is not been altered. In the roof space above there is some light cracking of the chimney breast, and although it is unlikely that this is due to any structural failure, from a single visual inspection it is impossible to be completely sure that this is the case.</p> <p>The left side chimney breast, serving the fireplace in the living room is, as far as can be determined, in a stable condition.</p>

Light cracking of the right side chimney breast in the roof space

Action Required	<p>Enquiries should be made to determine whether any alterations have been carried out to the chimney breast in the past.</p> <p>A structural engineer..... </p>

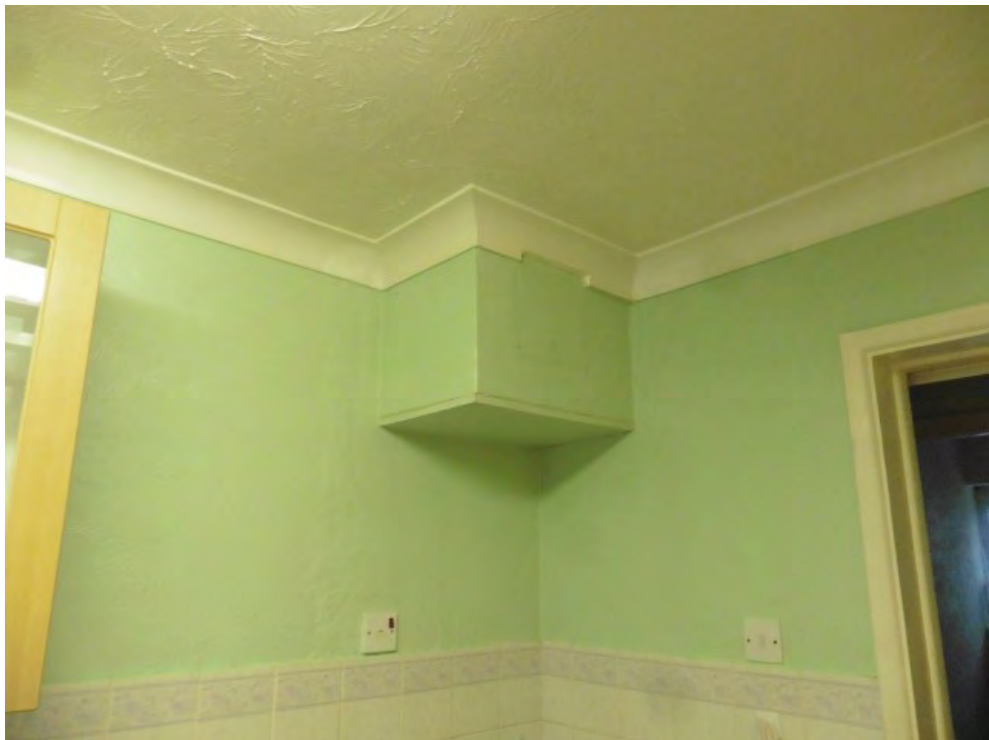
Right side chimney breast in the kitchen has been truncated

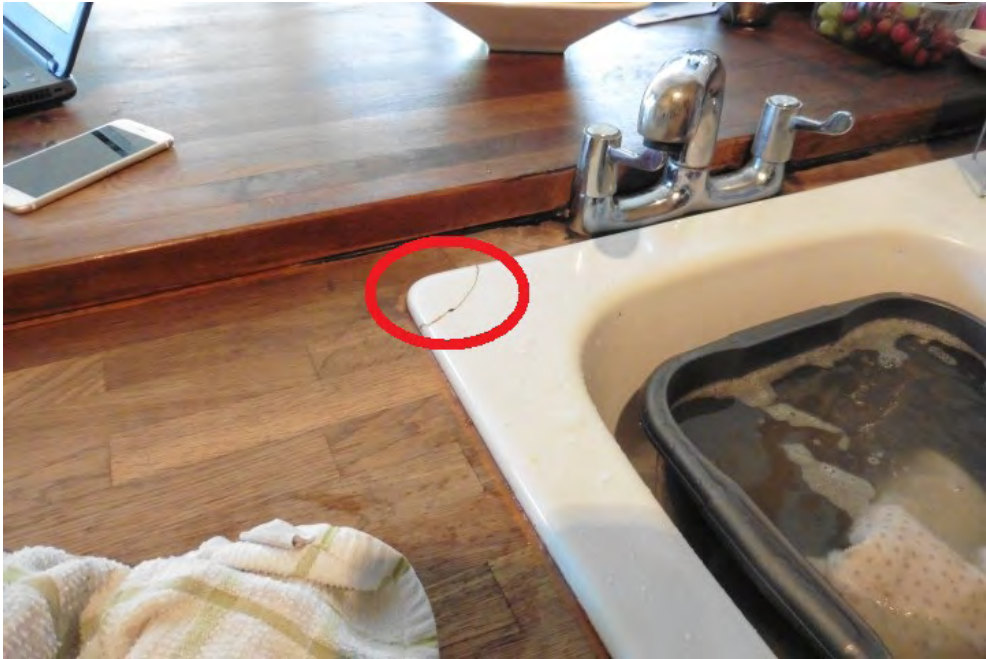
5.6 Built-In Fittings	Condition rating	2
Construction & Type	The kitchen fittings include wall and base units, drawers, sink and worktops. Other built-in fittings include wardrobes and cupboards.		
Nature of inspection and Limitations	The kitchen units were examined for general condition. A selection of cupboards and drawers were checked for normal operation and no significant defects were noted. Built-in appliances were not checked for operation or safety. Fitted wardrobes (and walk-in cupboards) were checked for general condition and door operation. No significant defects were noted but some modernising and updating may now be required.		
Condition	The kitchen fittings are of a modern style and in a serviceable condition. It is understood that they were installed by the current owners. The flow of water at the sink was checked and was within a normal range and considered to be suitable for the intended use. Hot water was obtained from the kitchen hot tap. Fitted cupboards and wardrobes are of a basic style and, generally in a serviceable condition. The cooker hood was found to be noisy in operation. The edge of the kitchen sink is cracked and will require repair.

</div> <p style="text-align: center;">Cracked edge to the kitchen sink</p>

Action Required	Maintain, repair or replace units as necessary. The fan within the cooker hood should be replaced. The kitchen sink will require replacement as it is cracked.		
	<div style="text-align: center;">

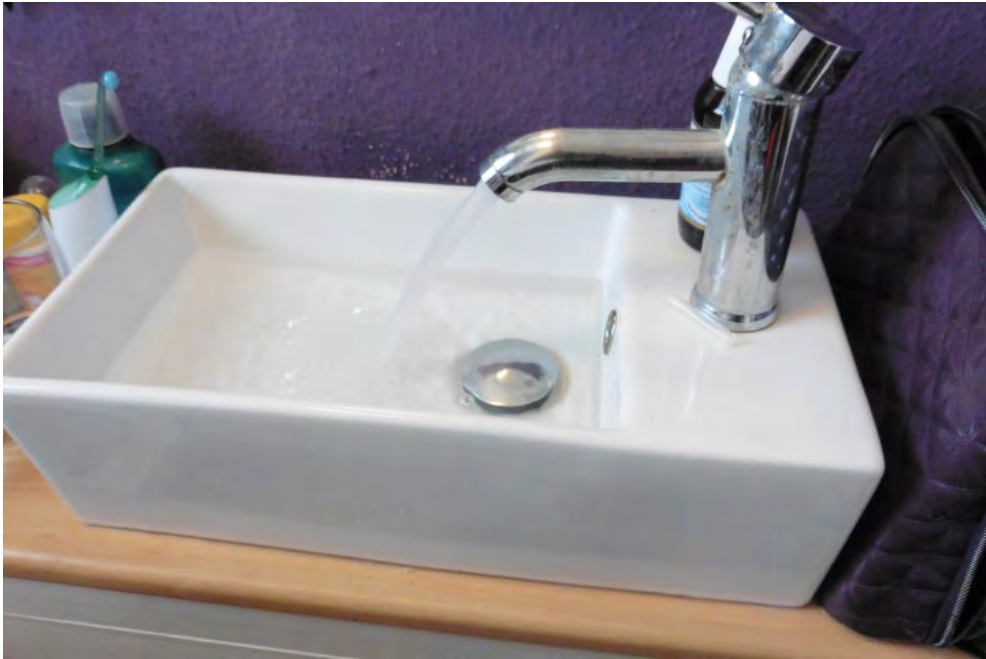
<h2 style="text-align: center;">5.8 Bathroom and Sanitary Fittings</h2>	<p style="text-align: center;">Condition rating</p>	<p style="margin: 0;">1</p>
<p>Construction & Type</p>	<p>The sanitary fittings in the bathroom and WC include such items as bath with mixer shower and curtain, basins and WCs.</p>		
<p>Nature of inspection and Limitations</p>	<p>As far as was practical, all of the sanitary fittings were checked for normal operation.</p>		
<p>Condition</p>	<p>All of the fittings checked were found to operate normally. They are of a basic style and in a serviceable condition. The flow of water at all outlets checked was within a normal range and considered to be suitable for the intended use. Hot water was obtained from all hot tap outlets, except for the first floor WC hand basin when no hot supply was available. It is not known if one is connected. It was also noted that water was slow to drain from this basin. The reason for this is not known.</p>

</div> <p style="text-align: center;">First floor WC basin has no hot flow and poor drainage</p>

<p>Action Required</p>	<p>Maintain, repair or replace units as necessary.</p>		
	<div style="text-align: center;">

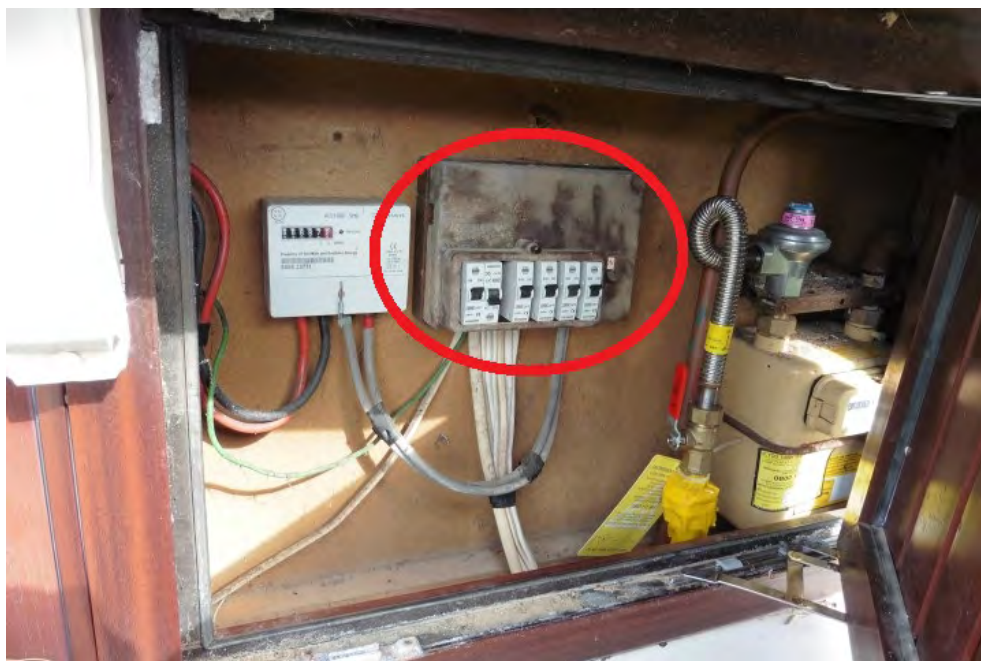
Fuse board

Condition	<p>The fuse board is of an older type without the more modern RCD protection devices installed, suggesting that it has not been upgraded recently. It must be assumed, therefore, that much of the installation dates from the 1970s or before and is, therefore, out of date. Although it was impossible to see most of the sockets in the rooms around the house, extension leads suggests that there are insufficient outlets for modern purposes. Power supplies to the sheds within the garden are, clearly, of an amateur nature and unlikely to meet reasonable safety standards. These supplies were noted to be of non-armoured cable.</p>		
Action Required	<p>The NICEIC recommends that electrical installations are subjected to an Electrical Installation Condition Report (EICR) by a competent person at least every</p> <p>.....</p>

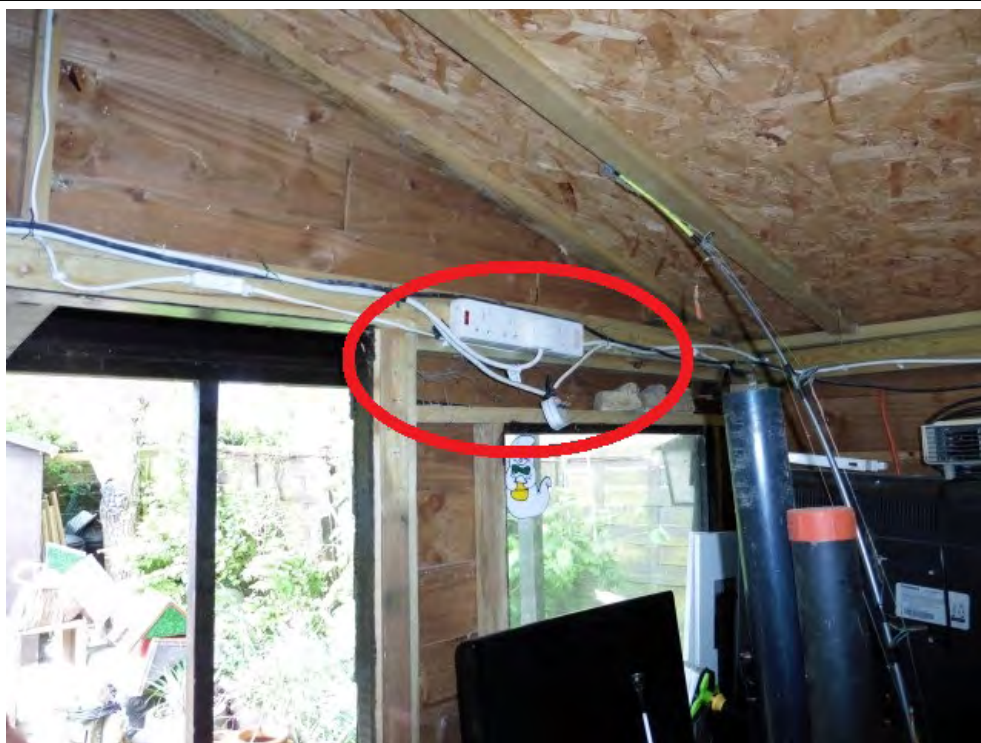
Poorly managed wiring in shed 4

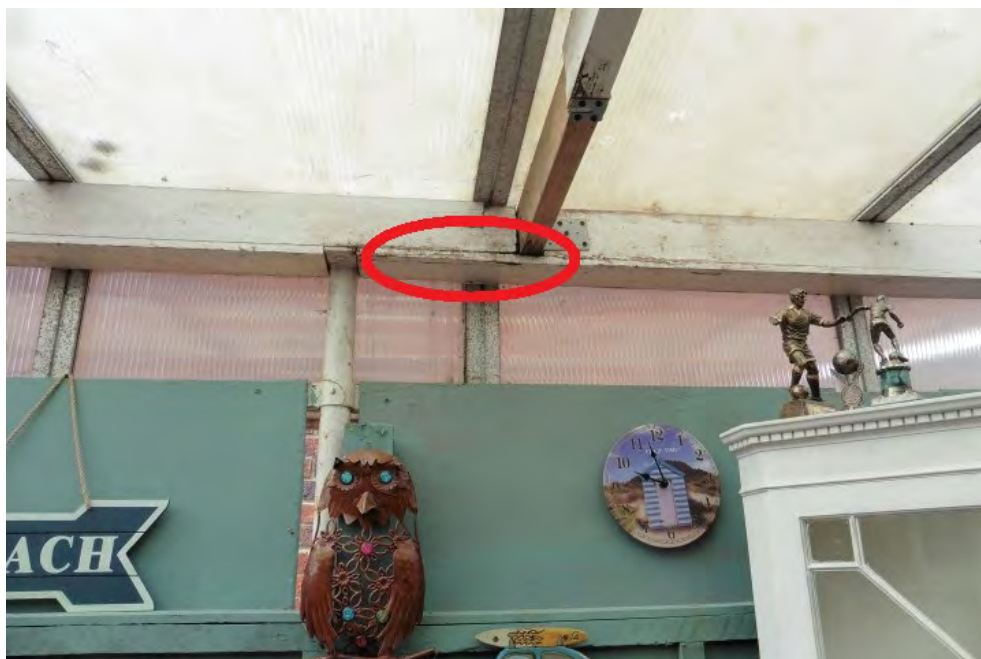
Possibly rotten timbers in the lean-to

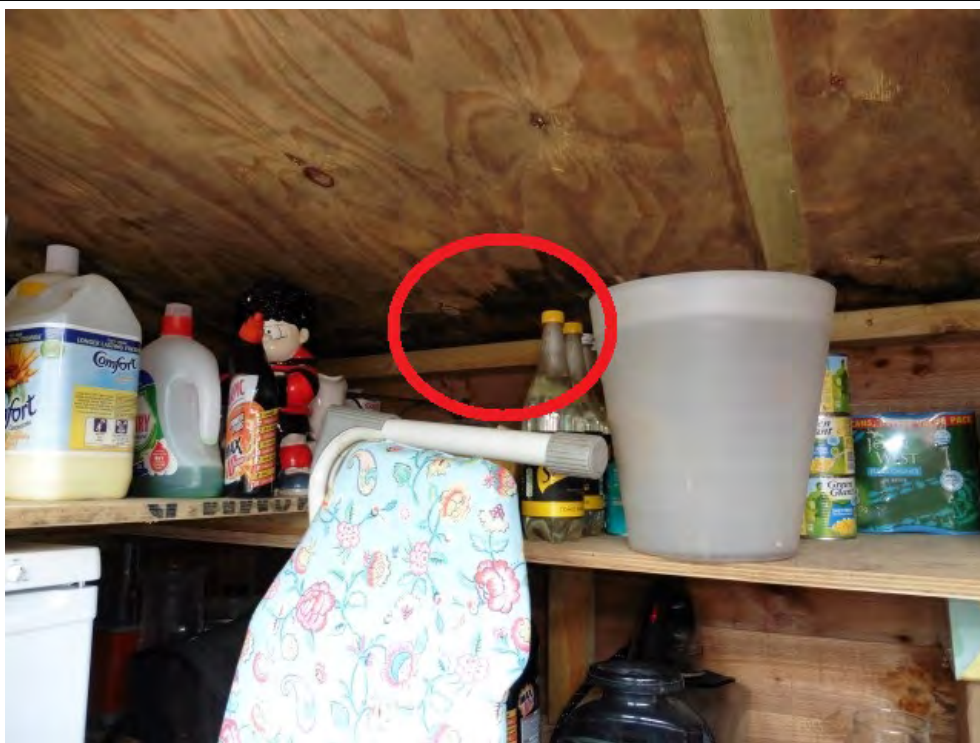
Staining on the underside of the roof of shed 2

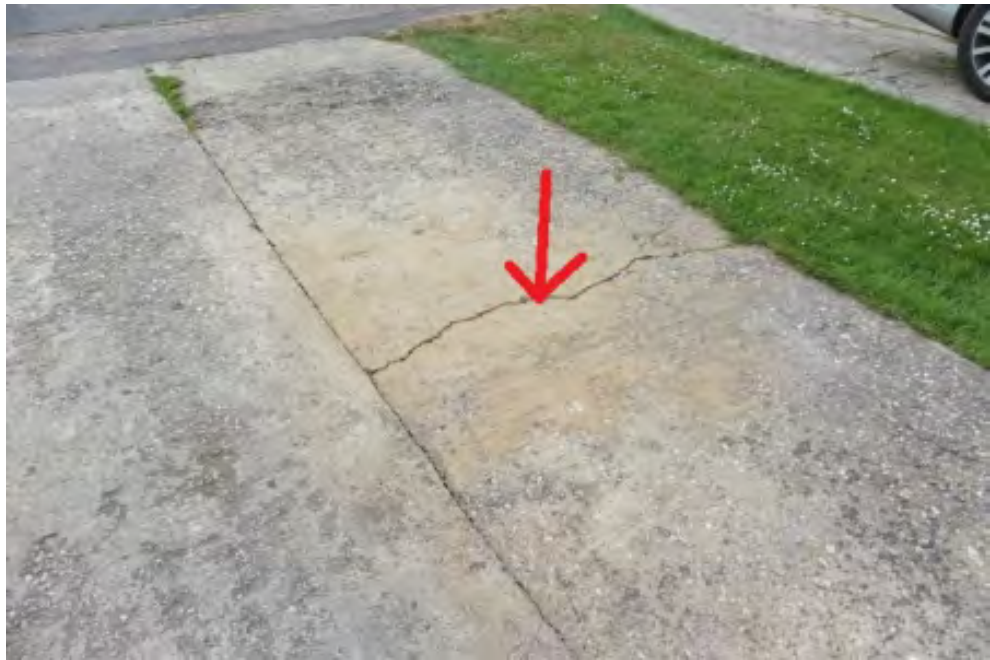
Cracking in the front drive

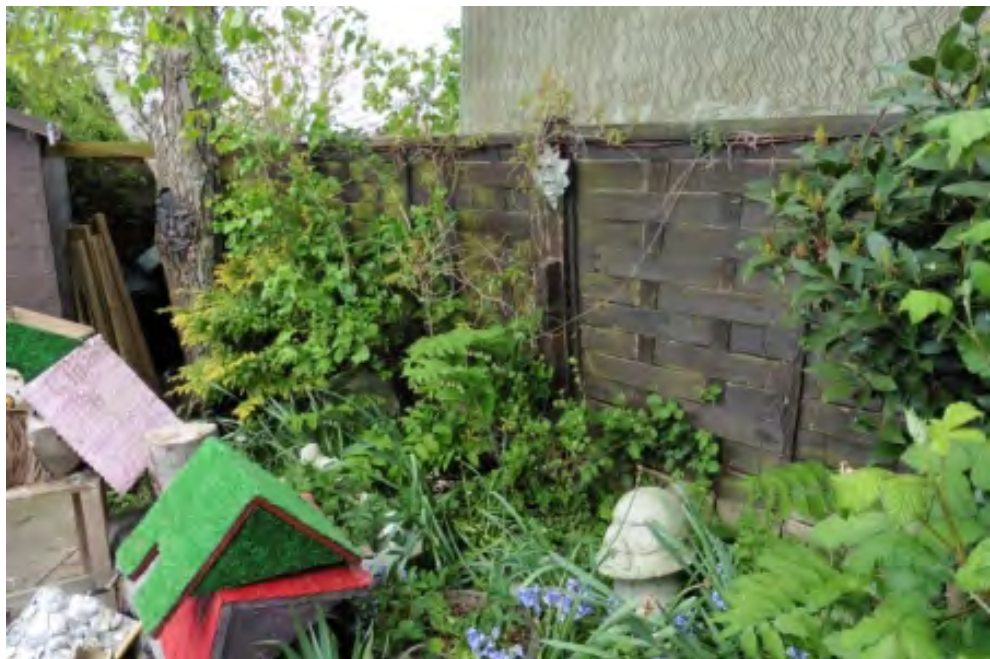
Rear boundary fencing maybe loose
