BUILDING SURVEY REPORT

PROPERTY Sample Survey
11 Florence Street
Anytown
AA11 1AA

SURVEY DATE 20 Nov 2019

REF 3974

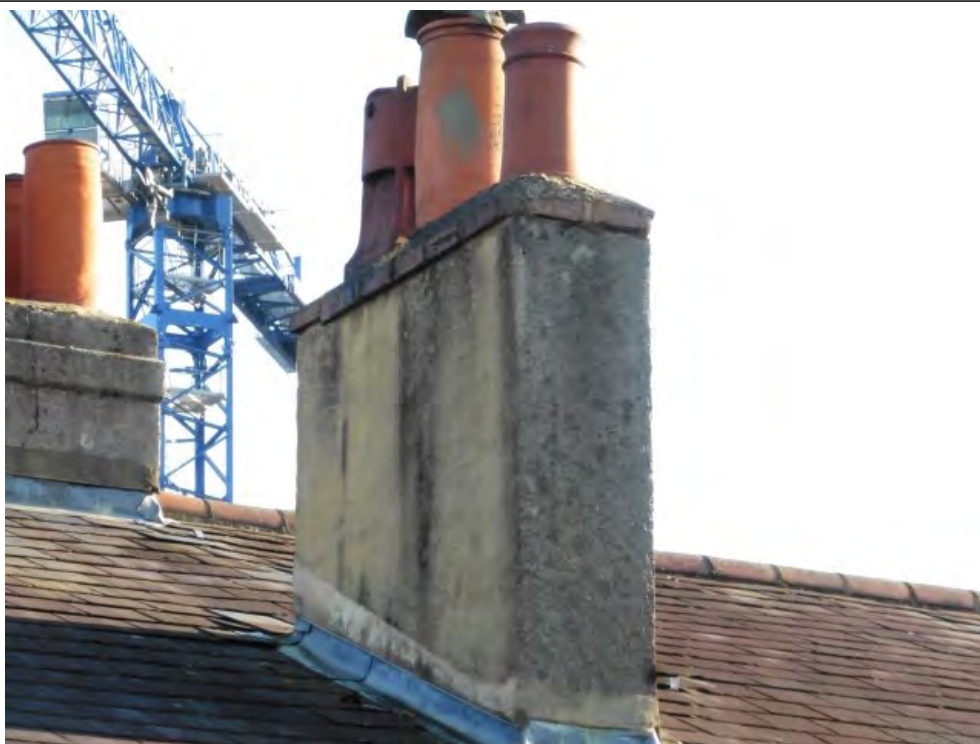
Rear stack viewed from the rear

Action Required	<p>The chimney stacks should be regularly monitored for any indications of damage, instability or other defects. You should carry out a thorough visual inspection at least once a year, ideally in the Spring, and ideally at roof level, to identify and repair any damage that could have been caused by winter weather.</p> <p>Missing, loose or defective mortar should be repointed as necessary.</p> <p>It is advisable to fit cowls on the top of the pots of any open flues.</p>

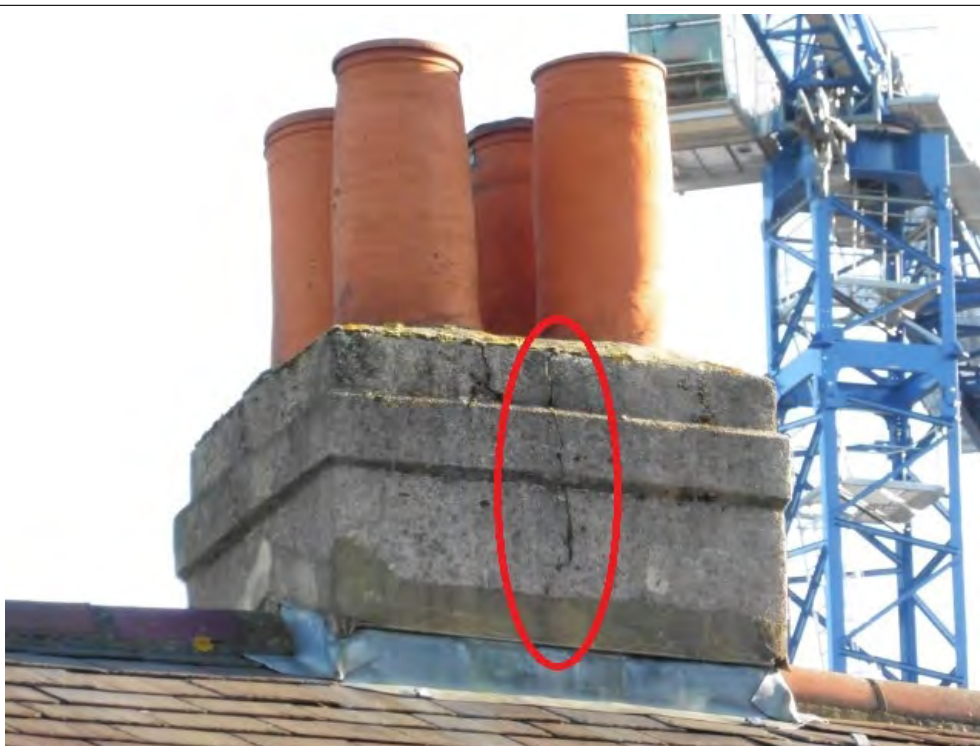
Central stack viewed from the front

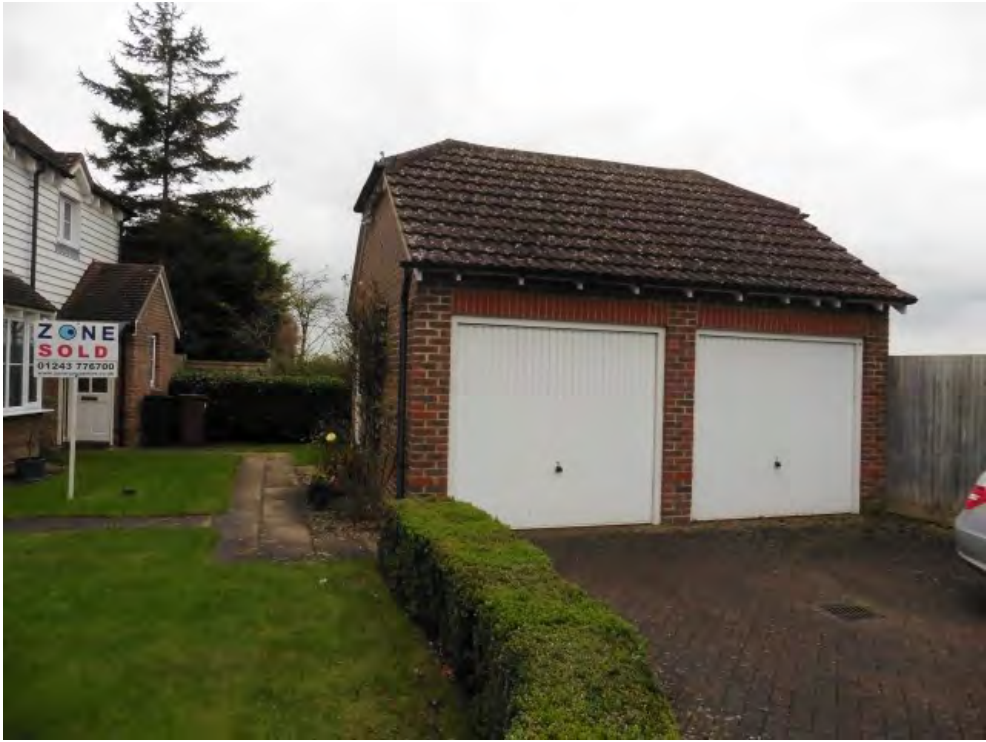
<p>Garage</p> </div>

7.1 Garaging	Condition rating	1
Construction & Type	<p>There is a detached double garage to the front of the house. It is of brick construction under a pitched and tiled roof. The floor is of concrete. The internal roof structure is of preformed timber trusses. At the front are twin metal up and over style vehicle access doors, and there is a timber personnel door on the side nearest the house.</p>		
Nature of inspection and Limitations	<p>It was examined from ground level, and with the aid of step ladders where necessary, for signs of bowing or leaning of walls, damaged brickwork, render and pointing, internal defects, and the condition of the roof both internally and externally.</p> <p>It was not possible to access the external right side of the garage as it falls within the curtilage of the neighbours property.</p>		
Condition	<p>The garage was found to be in a stable condition with no evidence of any cracking of the walls of floor which might indicate that it is subject to unusual structural movement such as subsidence or settlement.</p> <p>The roof covering is in a good condition without any undue numbers of slipped or missing tiles.</p> <p>All of the doors were found to operate normally.</p>

Action Required	<p>Normal maintenance, including regular retreatment of external joinery, is required.</p> <p>Foliage and debris should be removed from the outside walls.</p>		
	<div style="text-align: center;">
